# Glass Inspector

## CERTIFICATE OF ANALYSIS

| Date | 2025/07/01 17:59:08 |
| Batch number | 20250701175908 |

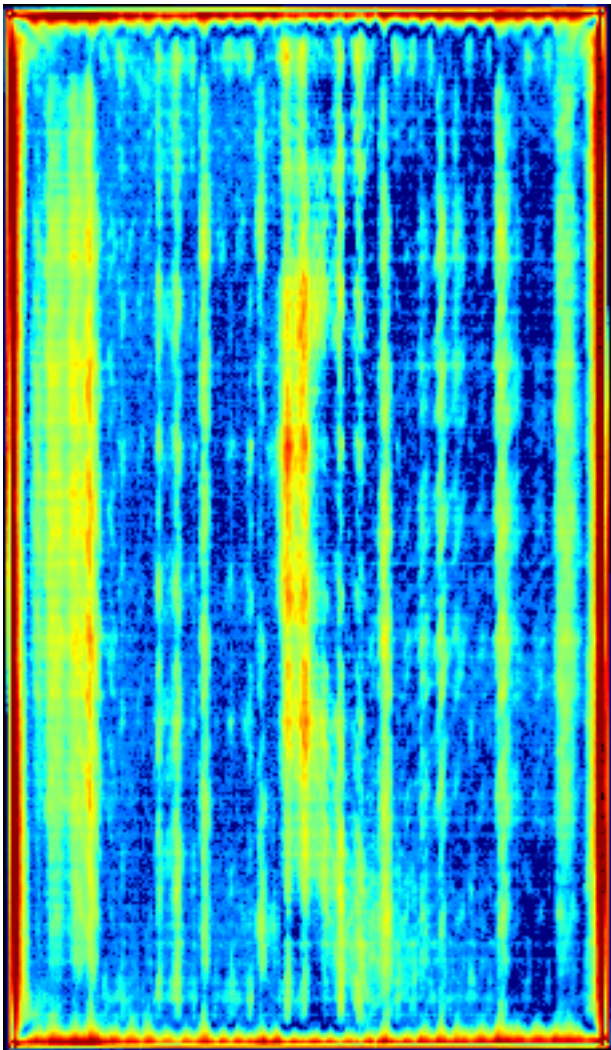
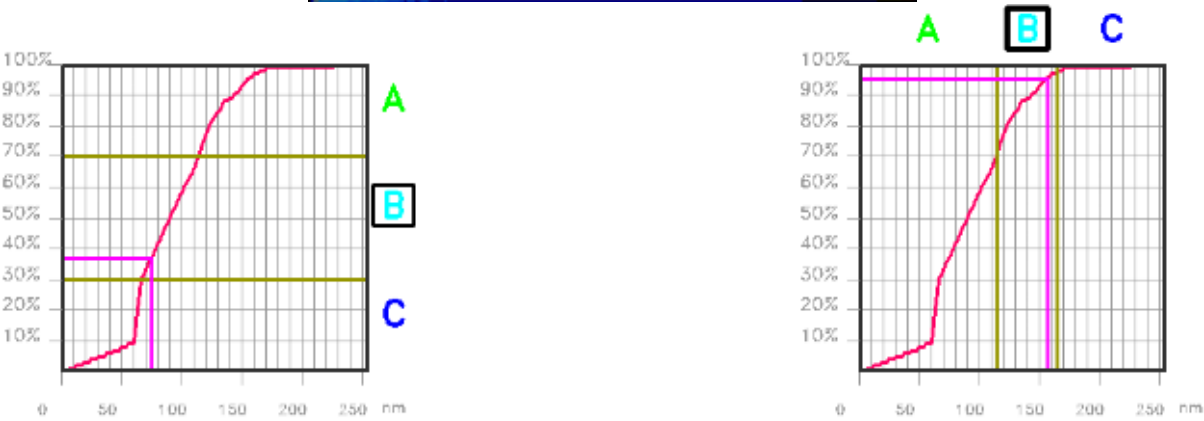
# Glass Inspector 4D – Anisotropy image

| Anisotropy analysis result | No OK |
| Cat. M. A | B |
| Percentil 95 | 157 |
| Cat. M. B | B |
| P% < 75nm | 37 |

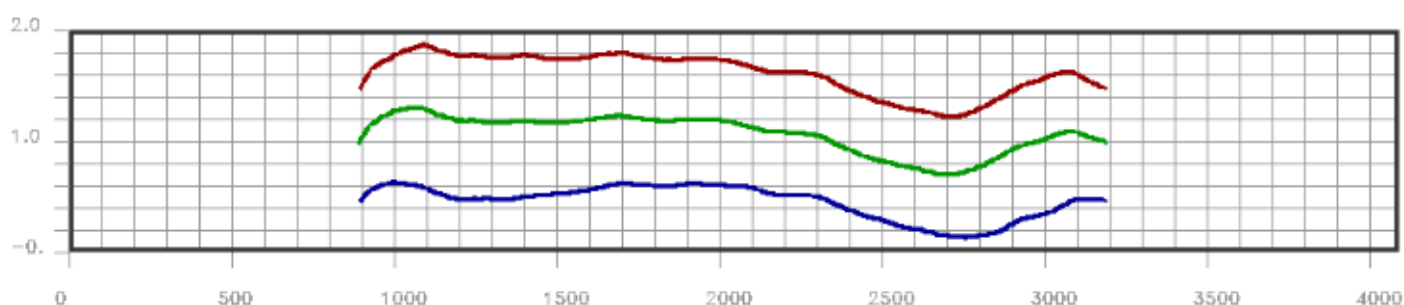
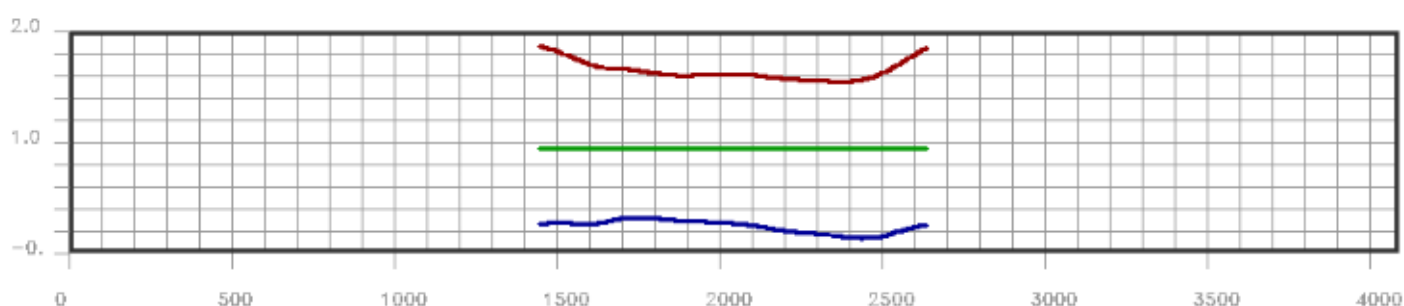
# Glass Inspector 4D - Distortion image

| Result | | Failed | |
| mD_L: Leading edge distortion | 45 | mm_ELL: Leading edge lift | -0.41 |
| mD_T: Trailing edge distortion | 66 | mm_ELТ: Trailing edge lift | -0.41 |
| mD_M: Central zone distortion | 34 | mm_Bow_Y: Longitudinal bow | 0.46 |
| mD_X: Transversal distortion | 0 | mm_Bow_X: Transversal bow | 0.31 |
| mm_PVL: Leading Edge peak/valley | 0.12 | | |
| mm_PVT: Trailing edge peak/valley | 0.06 | | |
| mm_PVM: Central rollerwave | 0.05 | | |
